MISCELLANEOUS PAPER S-73-30

# CONDITION SURVEY, KINCHELOE AIR FORCE BASE, MICHIGAN

May 1973

Conducted by U. S. Army Engineer Waterways Experiment Station  
Soils and Pavements Laboratory  
Vicksburg, Mississippi

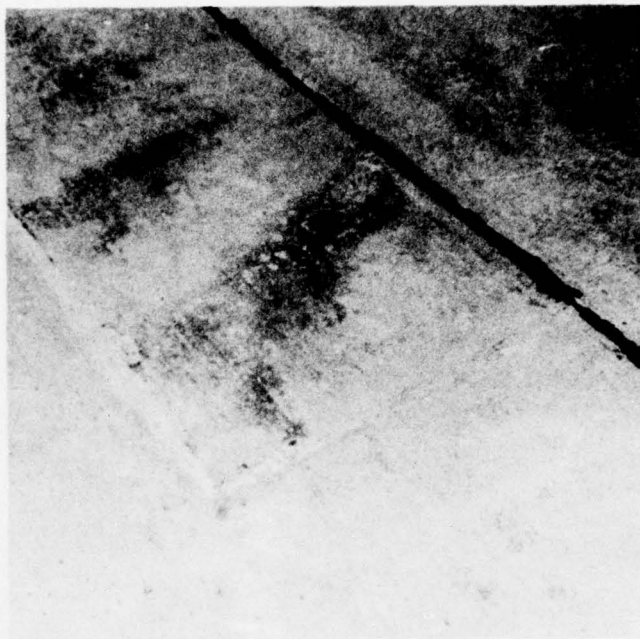
made with PCC and grout were more numerous from sta 10+00 to 50+00 than in other areas of the runway. Some of the repaired spalls were performing satisfactorily, and some were showing signs of slight deterioration (see photos 1 and 2). The pop-outs had also been patched with PCC.

Photo 1. Spall repaired with PCC (in good condition)

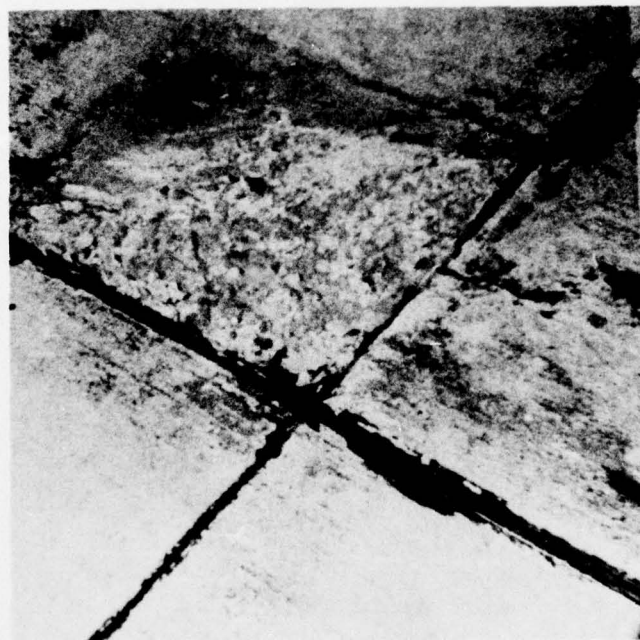
Photo 2. Spall repaired with PCC (deteriorating)

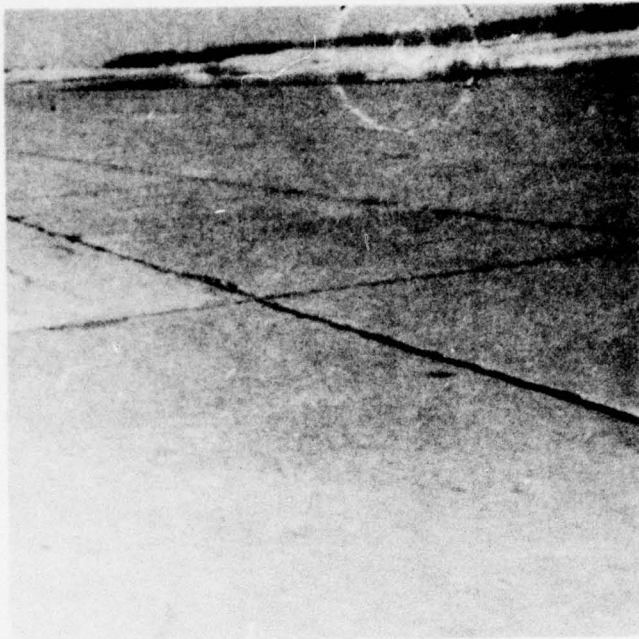
25. The ADC parking apron and operational apron were constructed in 1942 of 9-6-9-in. PCC. These aprons contained a moderate number of structural defects, pop-outs, and spalls. The PCC that has been used to patch the spalls and pop-outs has performed satisfactorily. Epoxy material has been tried on some of the spalls, but the patches have become unbonded and have had to be replaced. These aprons receive only light traffic and are considered to be in fair to poor condition (see photos 3-5).

Photo 3. Condition of ADC parking apron

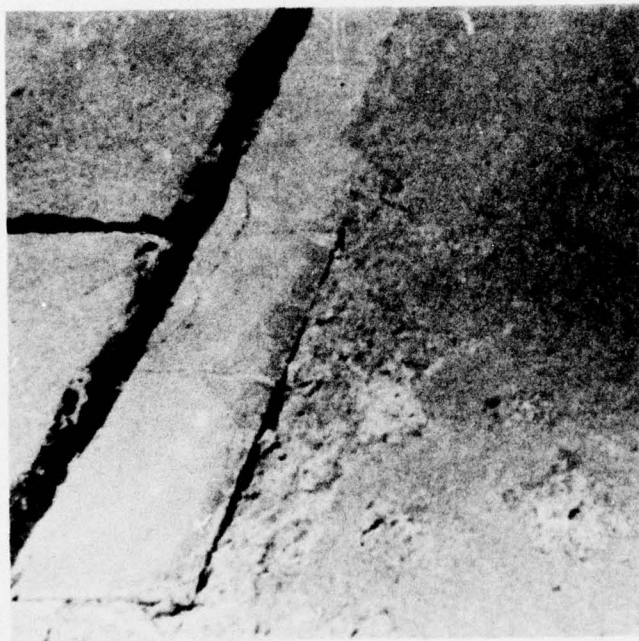
Photo 4. Spall repair on ADC parking apron

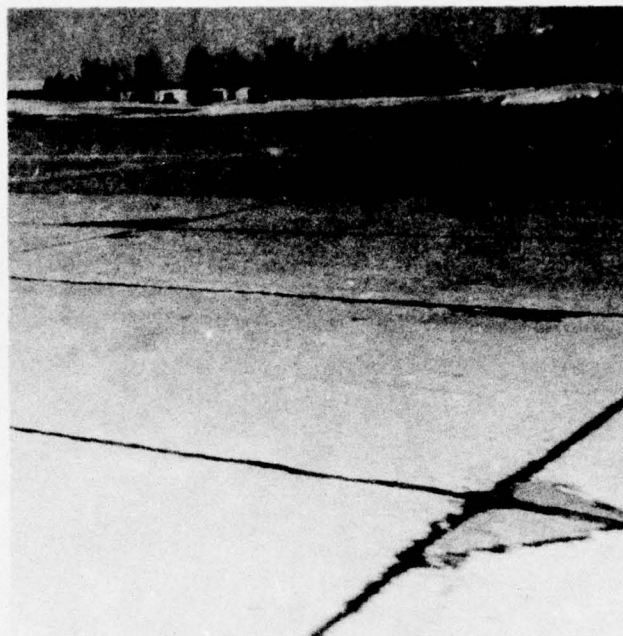
Photo 5. Condition of ADC operational apron

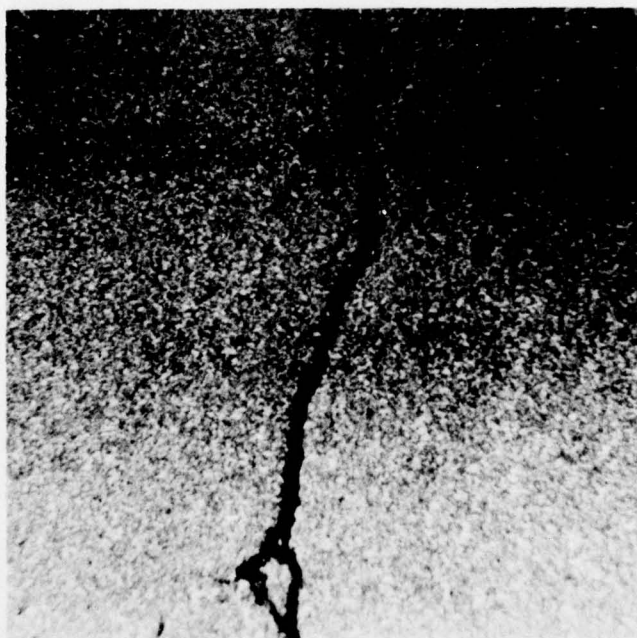
Photo 6. Longitudinal crack in north overrun

26. Taxiways 9 and 11 were surveyed in detail and were in excellent condition. The asphaltic concrete shoulders and blast pavements were in good condition, with only a minor amount of shrinkage cracking occurring. Some of the larger cracks, such as the longitudinal crack (photo 6) on the north overrun, need to be sealed.
